Safety Inspection Report

Annual Inspection

Woodland Playground

08 July 2024

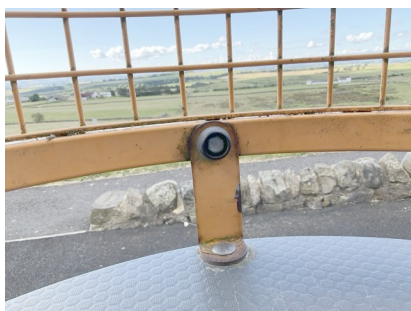
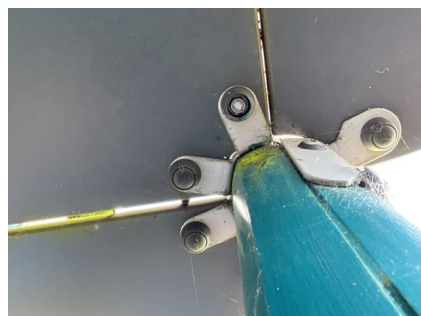
Cap missing.

Underside of platforms and base of look out post.

Very low

3

Replace.

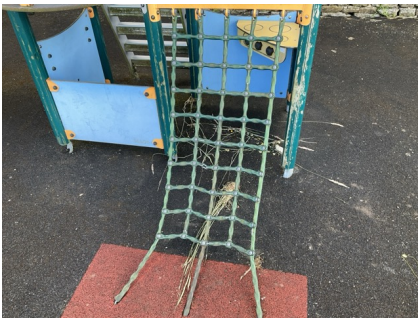
Chain covers prevent a thorough inspection of all chain links.

Low

4

No reasonably practicable action is identified.

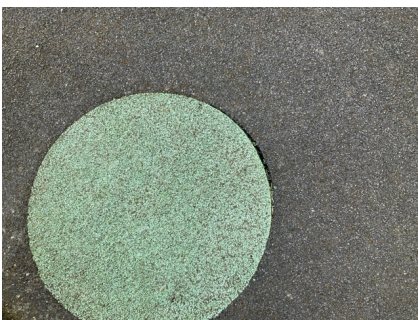
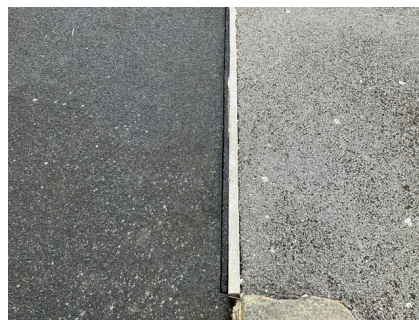
Shrinkage / separation of the surface. This may give a trip hazard.

Green graphic and entrance to path.

Medium

8

Re-glue and fill gaps and joints as necessary.

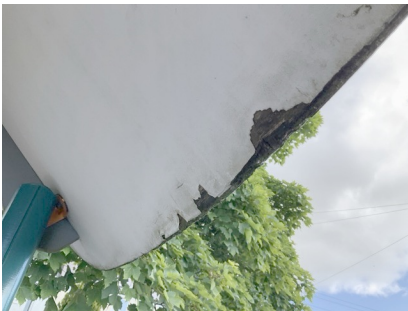
Laminate damaged.

Low

6

Rub down and treat damaged edges.

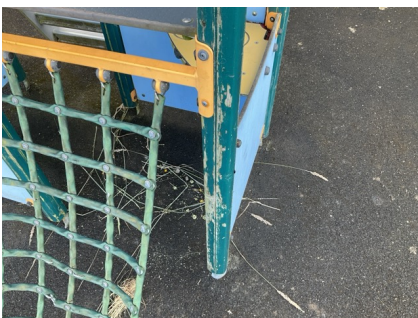
Timber preservation is in poor condition.

Very low

3

Stain with appropriate preservative. Most preservatives sold as child friendly by major DIY chains meet these standards (see advice in <http://www.rospa.com/leisuresafety/adviceandinformation/playsafety/wooden-play-equipment.aspx>).

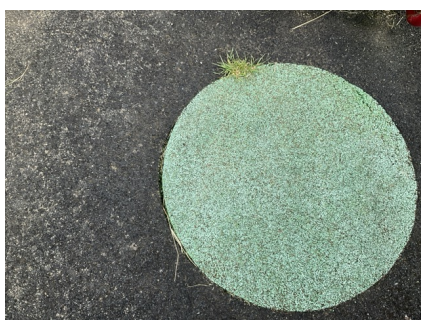
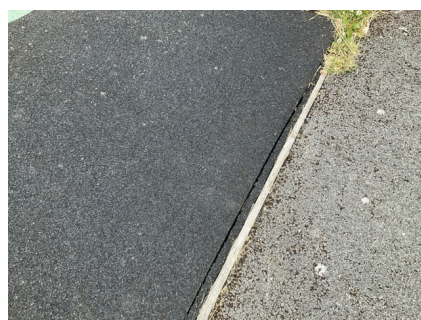
Shrinkage / separation of the surface. This may give a trip hazard.

Medium

8

Re-glue and fill gaps and joints as necessary.

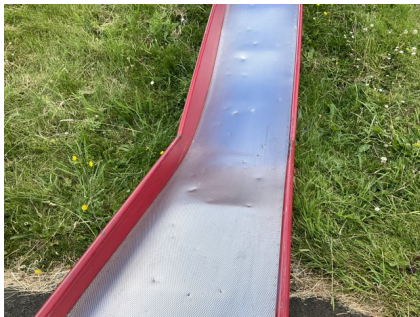
Item is bent.

Dents in slide bed. Monitor for further damage.

Low

5

Read the notes for further action.

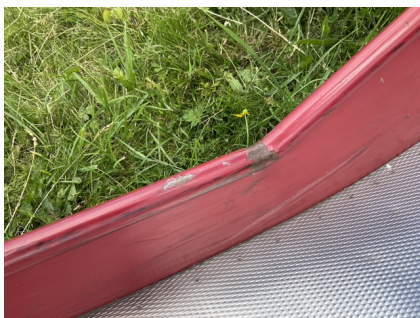
Paintwork is in poor condition.

Low

5

De-scale back to good base material and coat with lead free paint, using appropriate precautions. Repairs may be necessary where corrosion is severe.

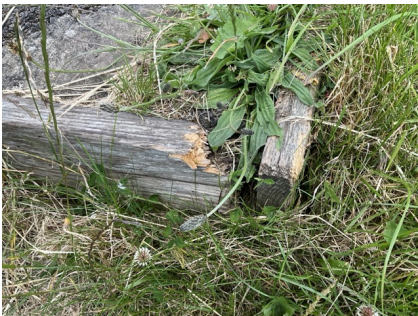
Timber is splintered.

Low

7

Repair.

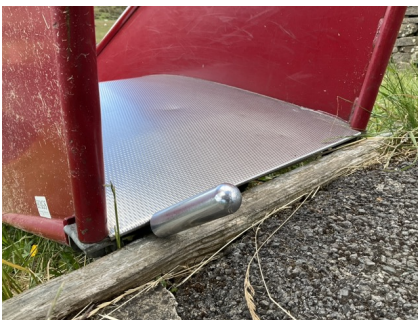
Finger entrapment.

Between timber and underside of slide start. Timber appears to have dropped or shrunk. Repair.

Medium

9

Eliminate the entrapment.

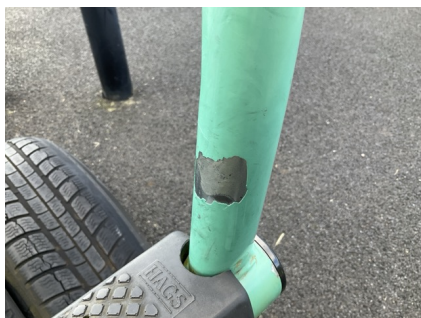
The paint is chipped.

Very low

2

Touch up the paint.

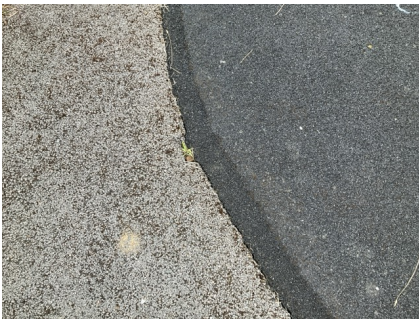
Shrinkage / separation of the surface. This may give a trip hazard.

Medium

8

Re-glue and fill gaps and joints as necessary.

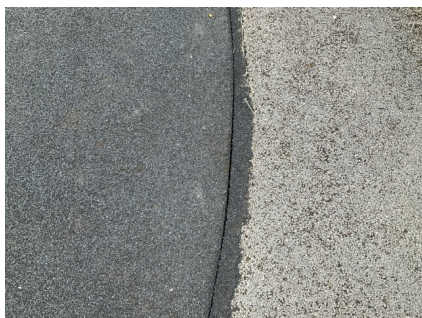
Shrinkage / separation of the surface. This may give a trip hazard.

Medium

8

Re-glue and fill gaps and joints as necessary.

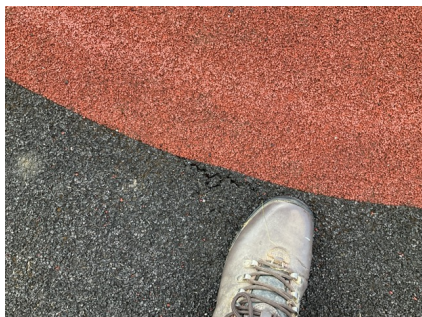
The surface is cracking.

Low

5

Monitor for any further deterioration and repair as required.
